Site C Clean Energy Project

Quarterly Progress Report No. 22

F2022 First Quarter

April 1 to June 30, 2021

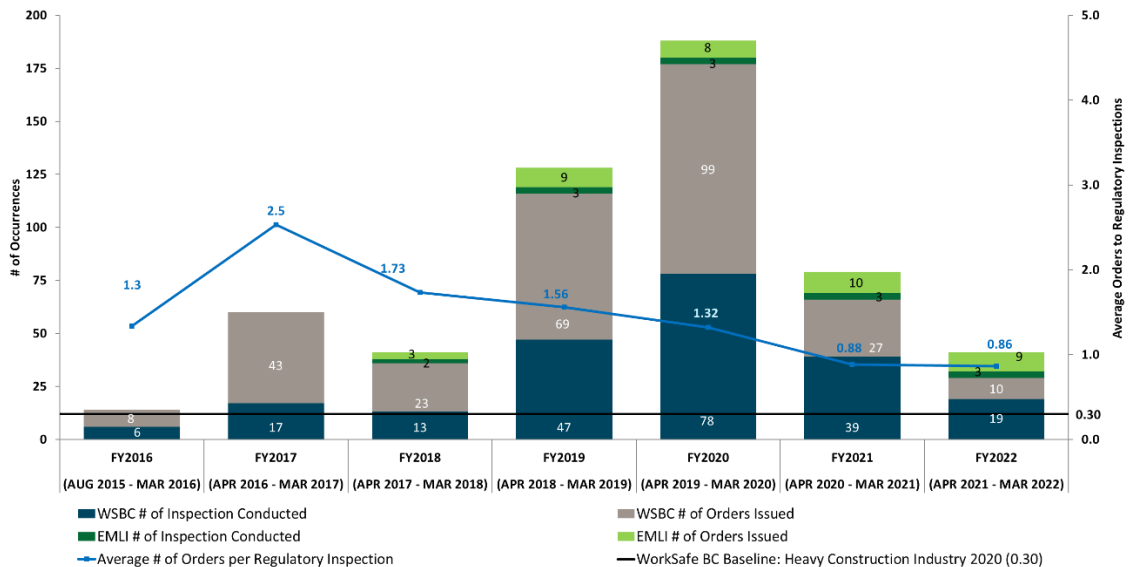
Figure 1 Number of Orders to Regulatory Inspections, August 2015 to June 2021

Reported April 1, 2021 to June 30, 2021 ⁹	Reported Since Inception (July 27, 2015 to June 30, 2021) ⁹
Regulatory Inspections	22	233
Regulatory Orders	19	318

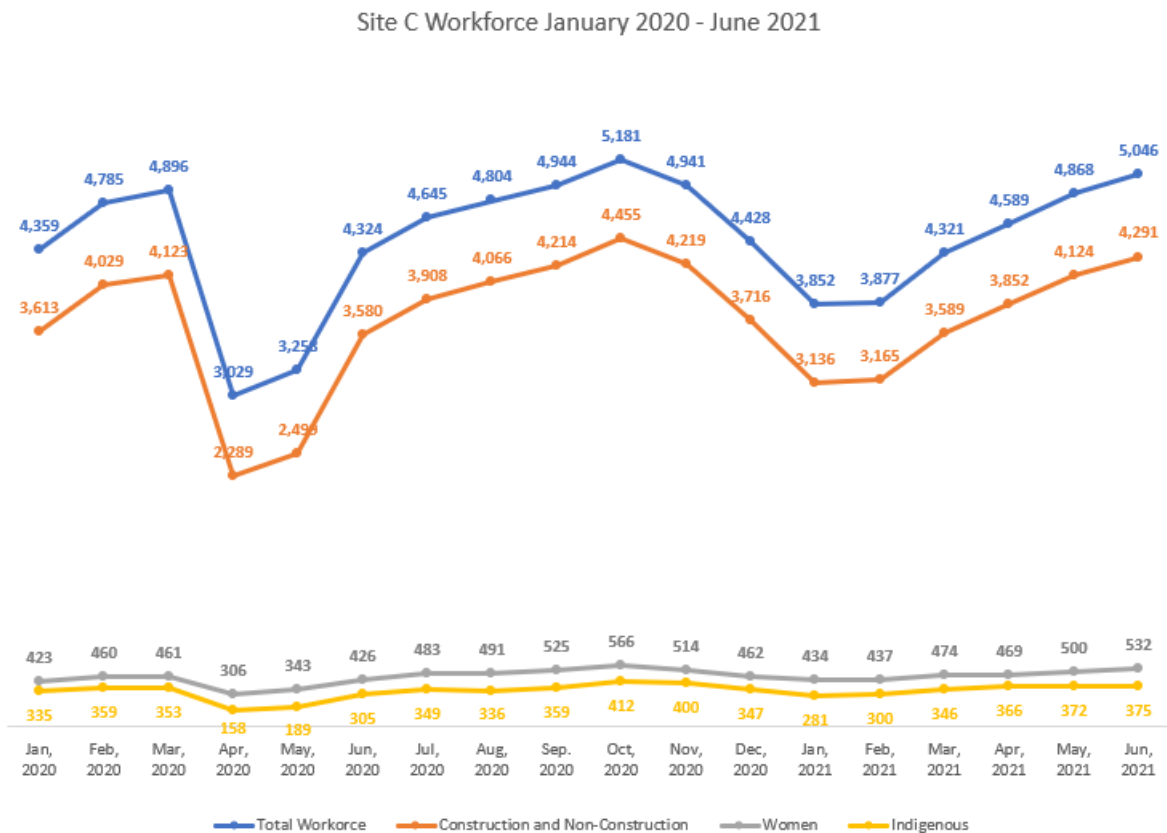
Figure 2 Site C Workforce June 2020 to June 2021

Note: The Indigenous and women numbers are a subset of the construction and non-construction contractors workforce number.

[Figure 2](#) below shows the monthly Site C workforce over the period from June 2020 to June 2021. The *Industrial Projects Restart Order*, which limited workers returning to site in January and February 2021, continued to impact the construction and non-construction workforce during the reporting period.

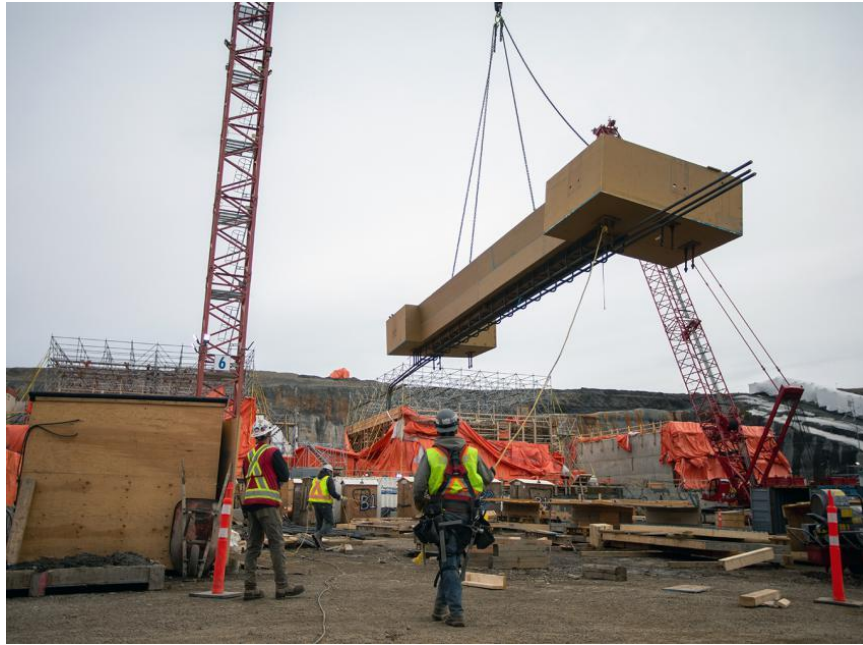
Figure A-1 Crews use a crane to lift formwork for placement at the spillway headworks (April 2021)

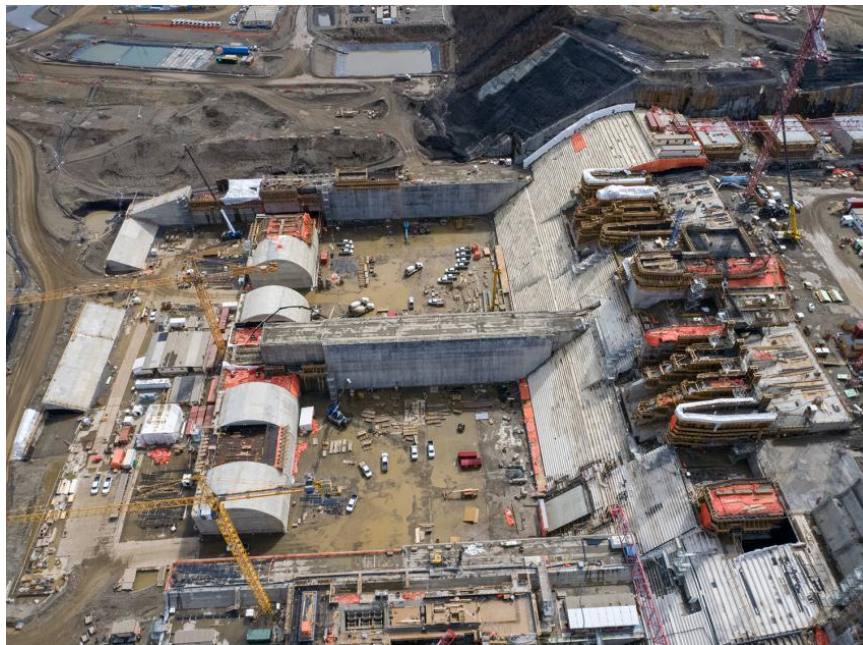
Figure A-2 The spillways, headworks and stilling basins (April 2021)

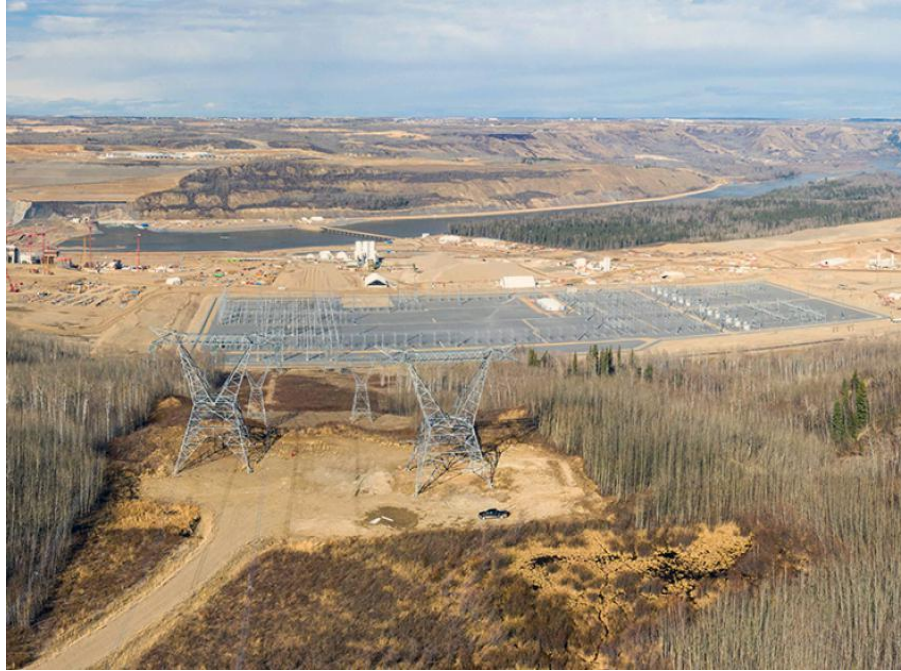
Figure A-3 **Transmission towers for two new transmission lines stand side-by-side above the completed Site C substation (April 2021)**

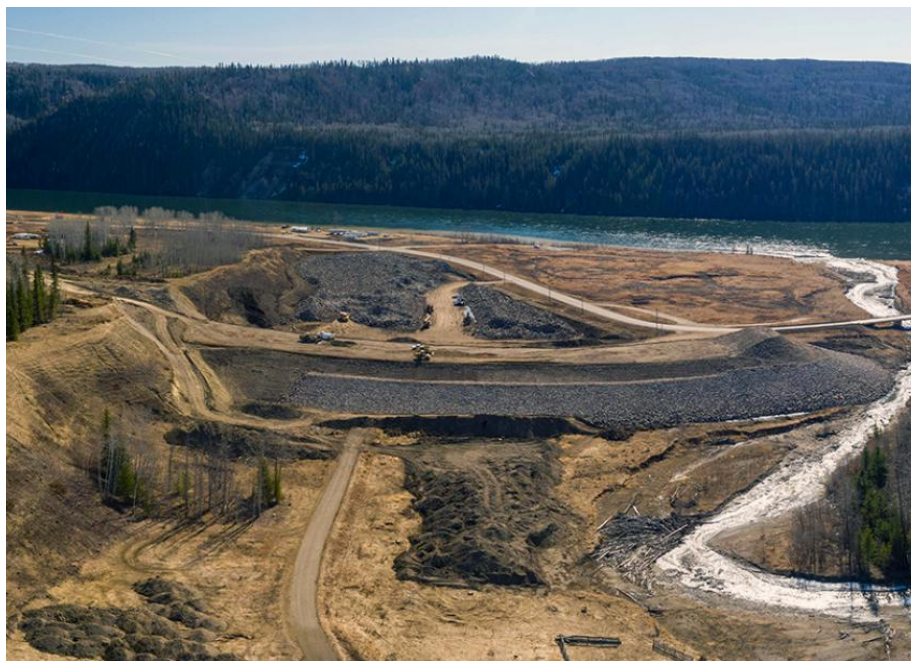
Figure A-4 **Causeway construction on the Highway 29 realignment at Lynx Creek (April 2021)**

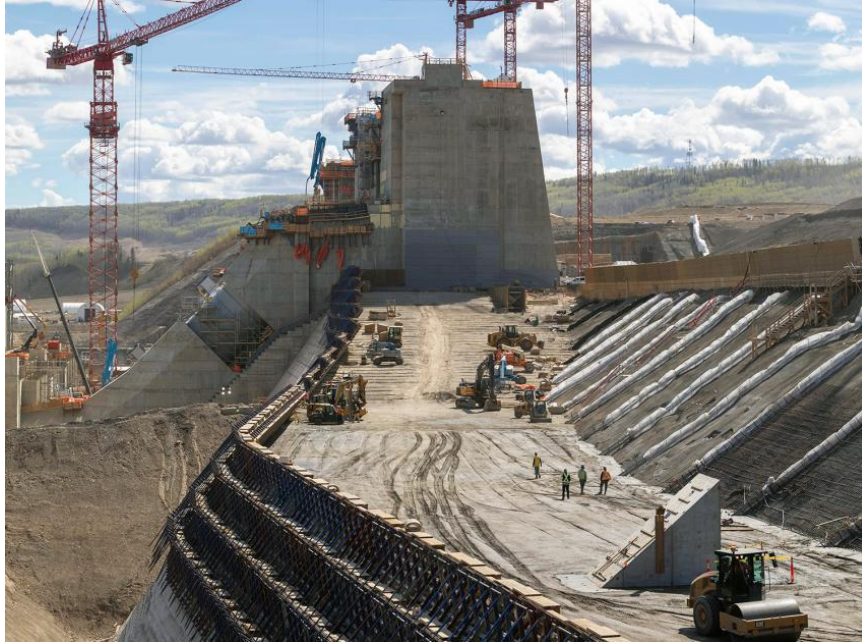
Figure A-5 Crews place roller-compacted concrete on the dam and core buttress (May 2021)

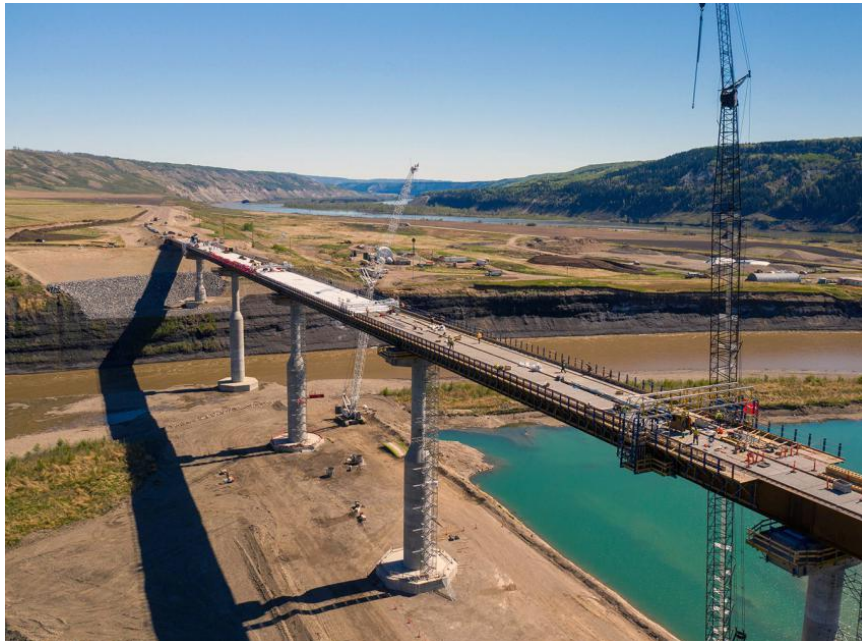
Figure A-6 Halfway River bridge showing cast-in-place bridge deck construction. The new bridge is over one kilometre long (May 2021)

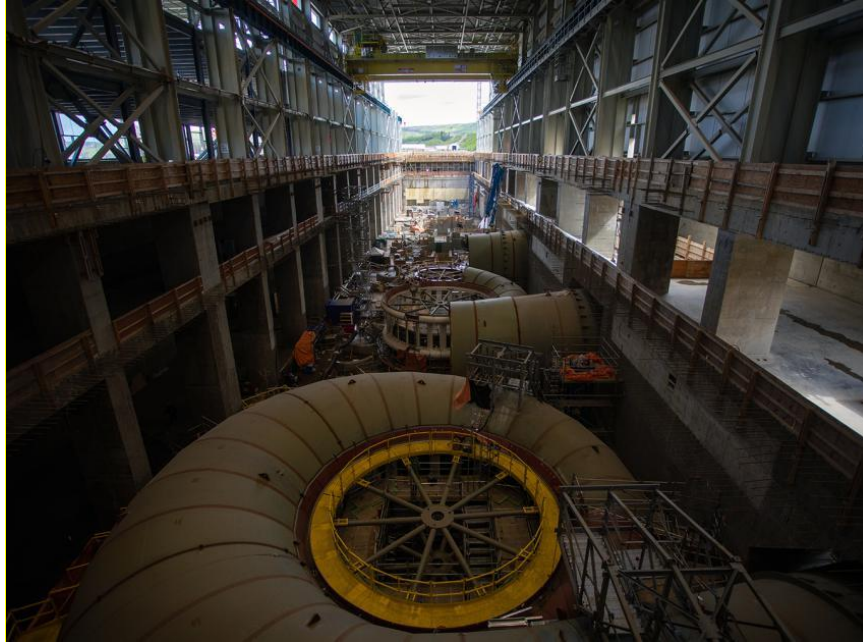
Figure A-7 Powerhouse component installation is underway for Units 1, 2, and 3 (May 2021)

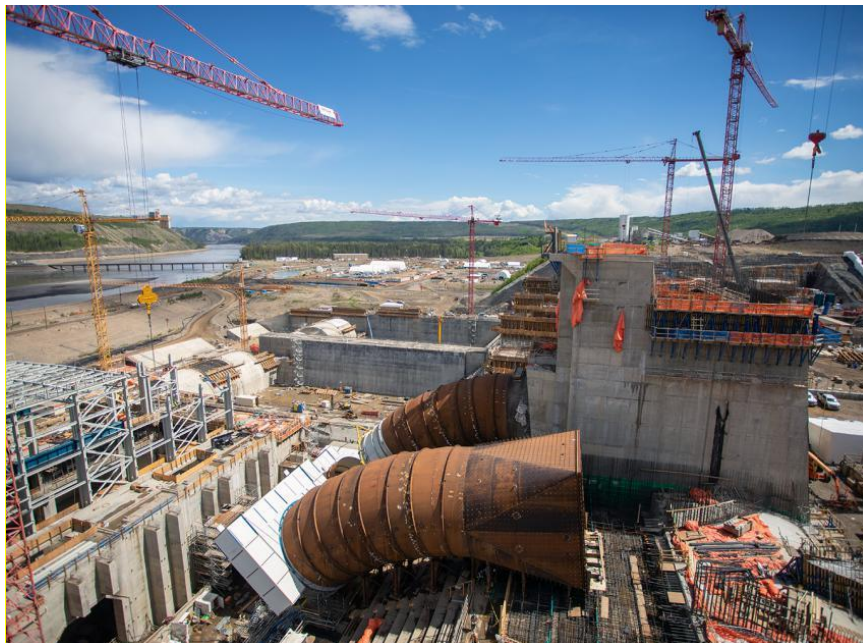
Figure A-8 An aerial view of the installation underway on the Unit 5 intake transition penstock section (May 2021)

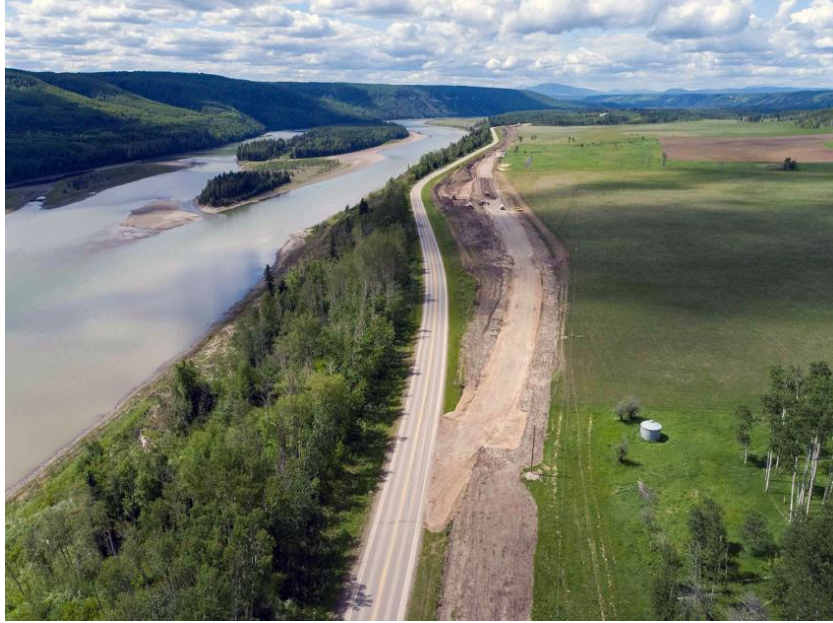
Figure A-9 Highway 29 construction at Farrell Creek east. Current activities at Farrell Creek include construction of a 411-metre-long bridge and 1.9 kilometres of highway realignment (June 2021)

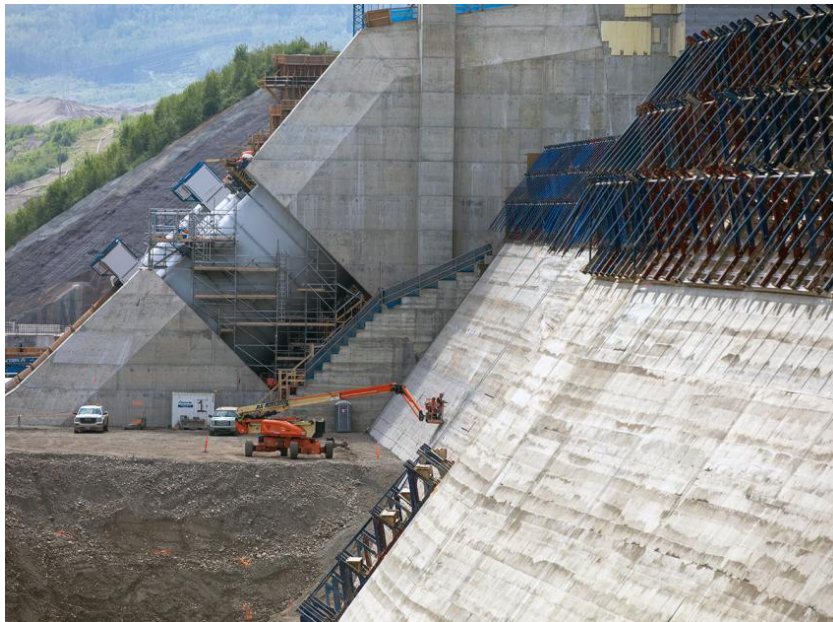
Figure A-10 Workers inspect the roller-compacted concrete at the dam and core buttress after the formwork is removed (June 2021)

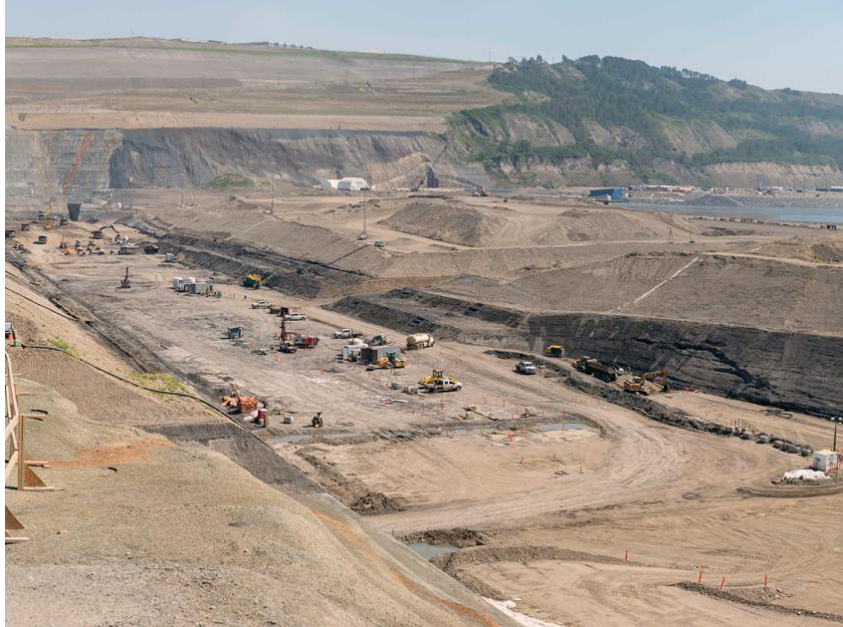
Figure A-11 The dam core trench showing the downstream shell of the dam (June 2021)

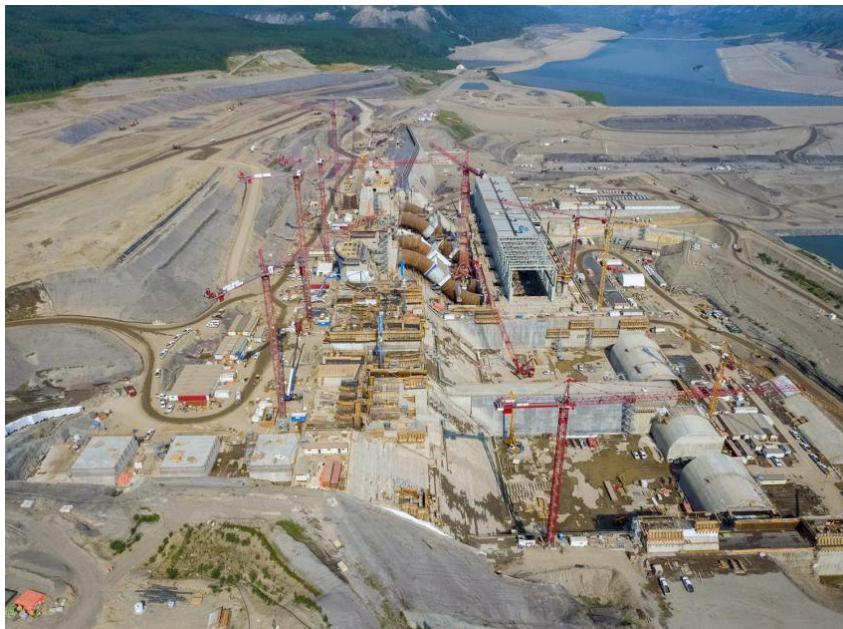
Figure A-12 An upstream view of the approach channel at top left and the powerhouse, generating station, and spillways at centre (June 2021)

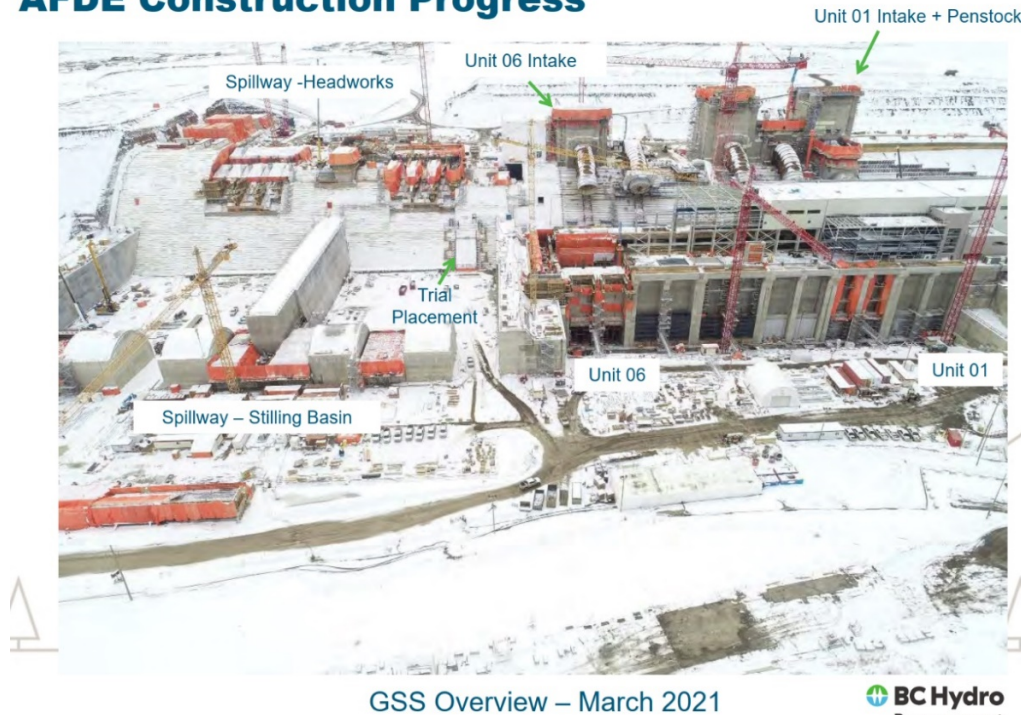
The GSS Civil Works design and engineering is well advanced, with 99% of the drawings issued for construction (IFC) design. The photograph presented below illustrates the status of the activities.

AFDE Construction Progress

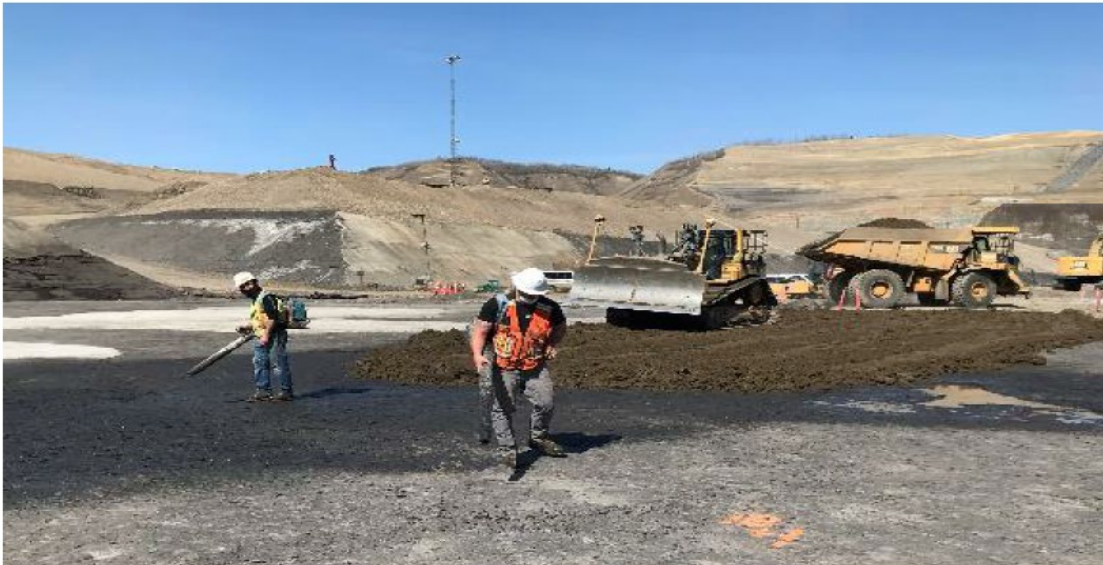
The first fill on the foundation is illustrated in the photograph below.

The TAB is favourably impressed with the careful attention being paid in the field to foundation mapping and treatment, control of construction equipment, and recognition of the care required at all material interfaces. The TAB is of the view that the direction of the data gathering, control of construction and material management are at the highest level. This early phase earthworks also validates that the material selections and specifications are fit for purpose.
